Review of Meeting Minutes June 27, 2024

Project Update Works in Progress

Update on River Monitoring Program

Cantilever Construction Update

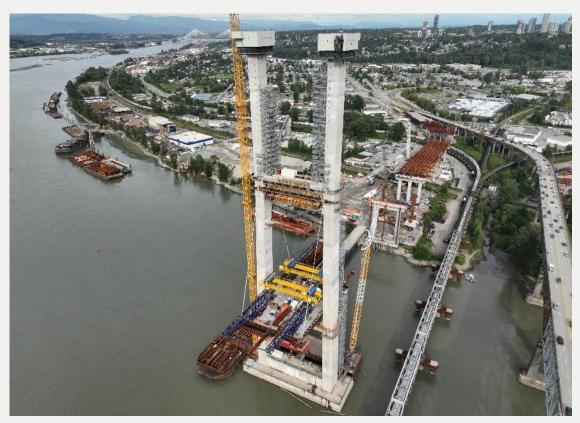
Photo 1: Pier S1, looking northwest

S1 Tower and Cantilever Construction

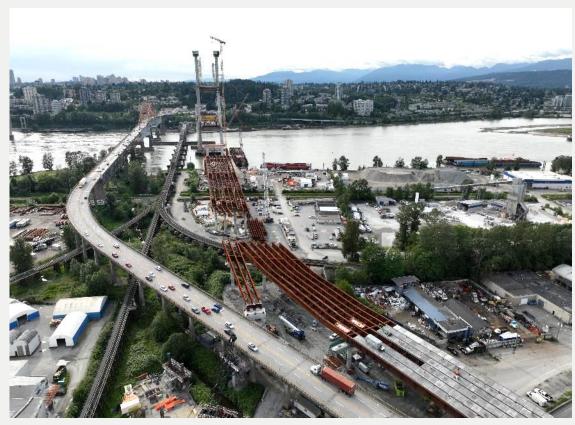
Photo 3: Looking northeast towards Pier S1 – South approach girder and deck installation works ongoing

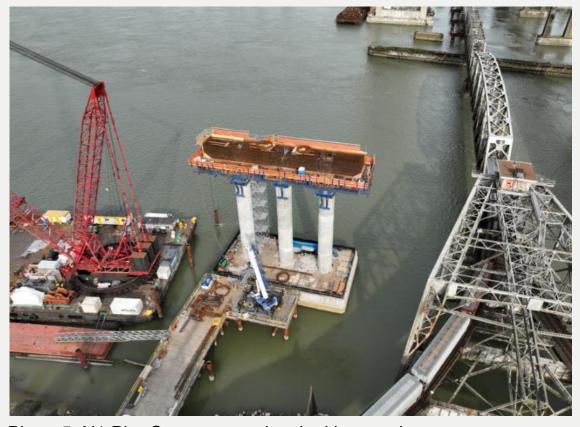
Photo 5: N1 Pier Cap construction, looking south

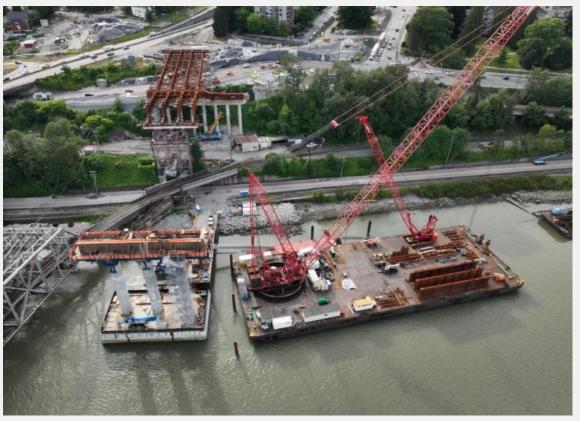
Photo 6: N1 Pier Cap construction, looking north

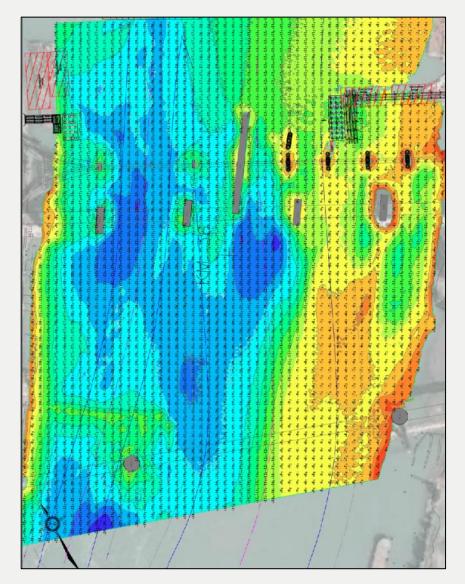
Bathymetry Monitoring Survey – July 2, 2024

- Monthly bathymetric survey results being shared at IMUWG and MUWG meetings
- Post-freshet comparison by cross sections (A-F)
 - a) Current Bathymetric Survey Results (Jul 2, 2024)
 - b) Existing Condition (pre-Construction)
 - > CN Rail Bridge without seismic retrofit, Pattullo Bridge, SkyTrain Bridge
 - c) Worst Case Construction Condition (Construction)
 - ➤ CN Rail Bridge with seismic retrofit, Patullo Bridge, SkyTrain Bridge, NFRB, Pier S1 and N1 scour protection, S1 and N1 TWP, CN3/CN4/CN5 scour protection, north bank erosion protection

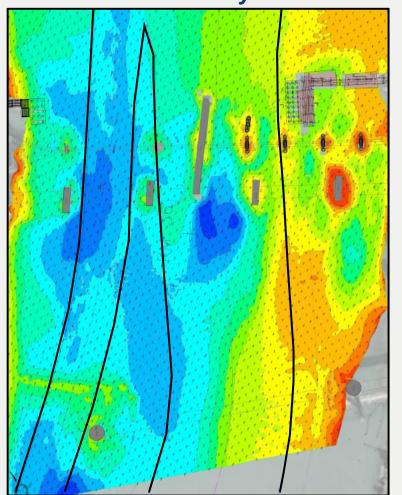
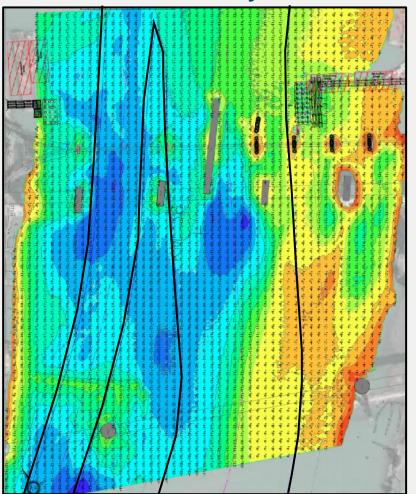
Bathymetry Results: Comparison from January – July 2024

Local Area Survey Jan 4/24

Local Area Survey Jul 2/24

- N1 pier cap construction underway
- FCCGP provided an update on the River Monitoring Program
 - Comparison of the January 4, 2024 and June 3, 2024 bathymetry results reveals the migration of depositions where the water lots are a known concern of the Council of Marine Carriers

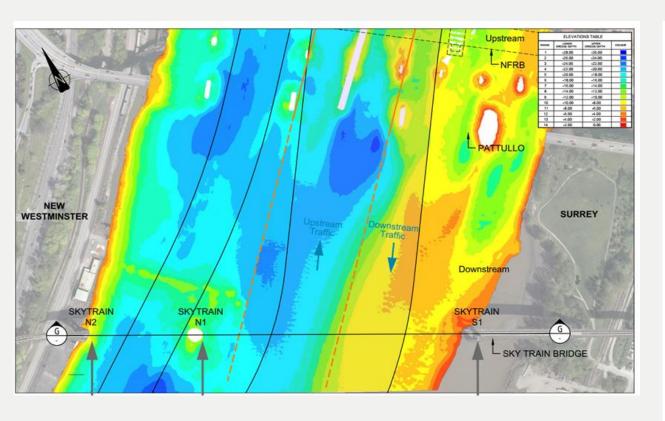
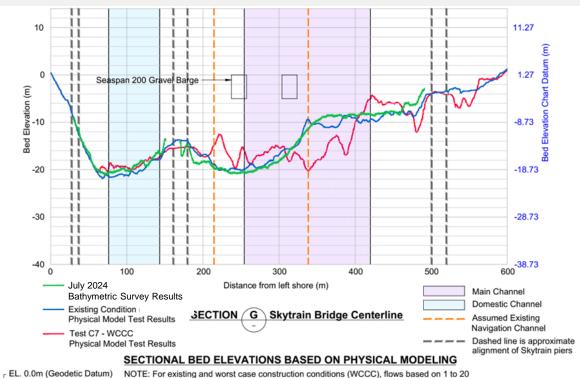
Section G: SkyTrain Bridge Centreline

year freshet of 15,815m³ per second that occurs less than 0.1% of the time.

Tide conditions combined with high river flows have been observed to cause local bed

levels to fluctuate up to 7m over a 24 hours period on both sides of the CN Rail Bridge.

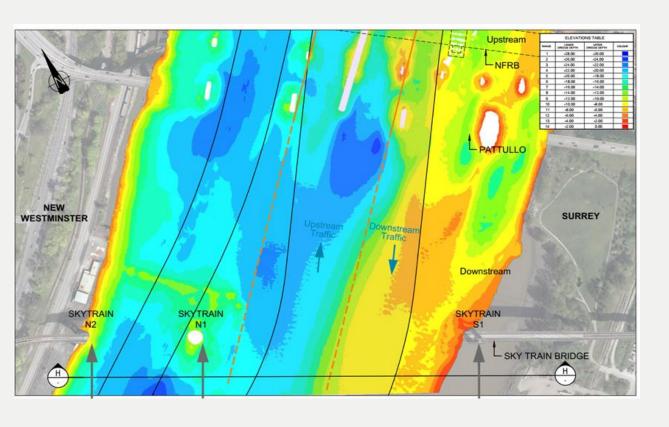
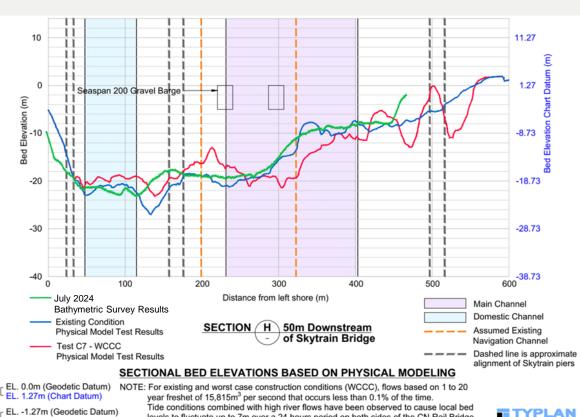
Section H: 50m downstream of SkyTrain Bridge

levels to fluctuate up to 7m over a 24 hours period on both sides of the CN Rail Bridge.

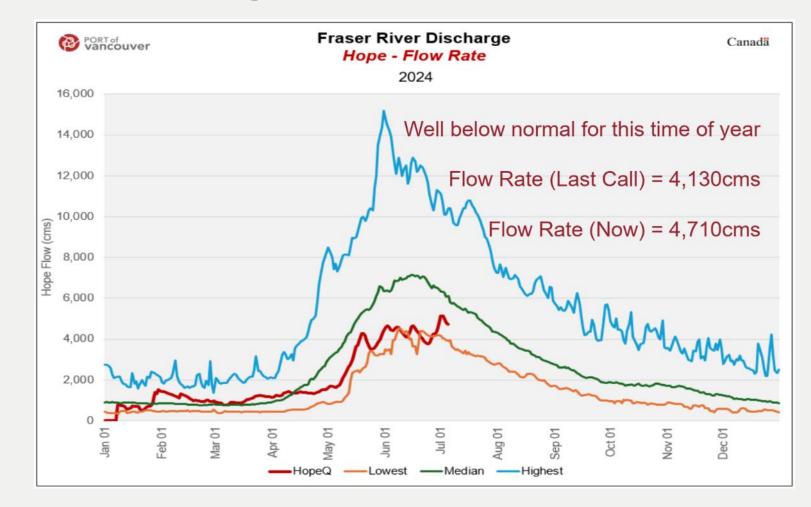
Fraser River Freshet

- Dynamic nature of Fraser River flows:
 - Flow rates up to ~1,000 m³/s in winter; 5,000-15,000 m³/s during freshet
 - Tide conditions combined with high river flows have been observed to cause local bed levels to fluctuate up to 7 m over a 24-hour period, and up to 12 m over a year
- Deposition occurring on south side of river
 - 2024 freshet flows were less than historical average

Lowest, Median, Highest Freshet Compared to 2024

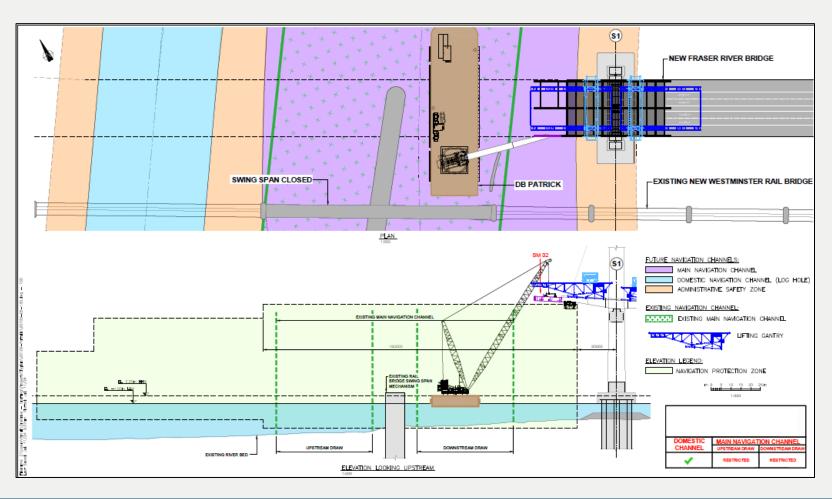
Cantilever Construction – SM-02 to SM-03 Works Alternative Considered

In advance of lifters becoming operational, Project has been looking at bringing DB Patrick barge/crane to site to facilitate SM-02 segment girder placement.

- Challenges with Lifters
- Alternative solutions to continue progressing with SM-02 and SM-03 involve lifting structural steel and precast panels using derrick barge(s)
- Restrictions to navigation channel (downstream draw) to accommodate derrick barge(s) and/or their anchors
- Alternative methodology should not extend past SM-03
- Anticipate lifters will be in operation again by early August

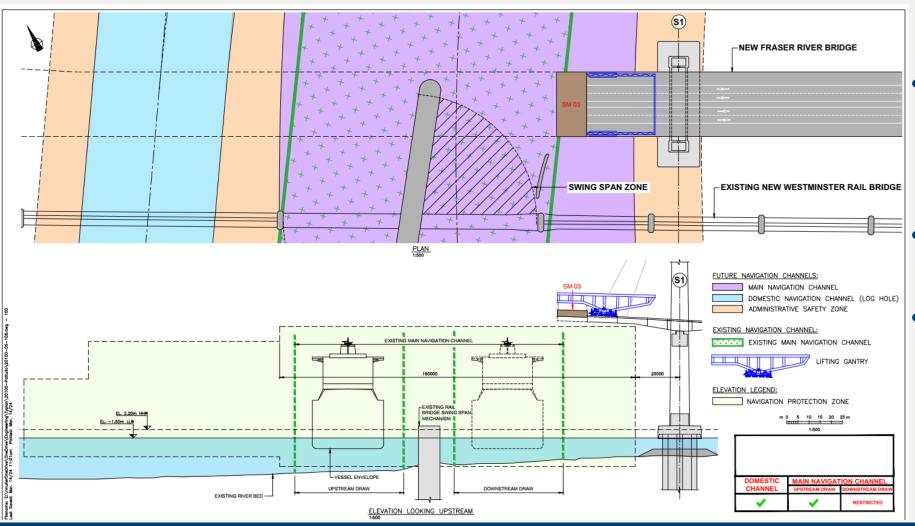
Construction Staging – Cantilever Construction Segment SM-03

- Starting early
 August pending operation of lifters
- Three-week duration
- Restrictions in the downstream draw (approx. 11 hours)

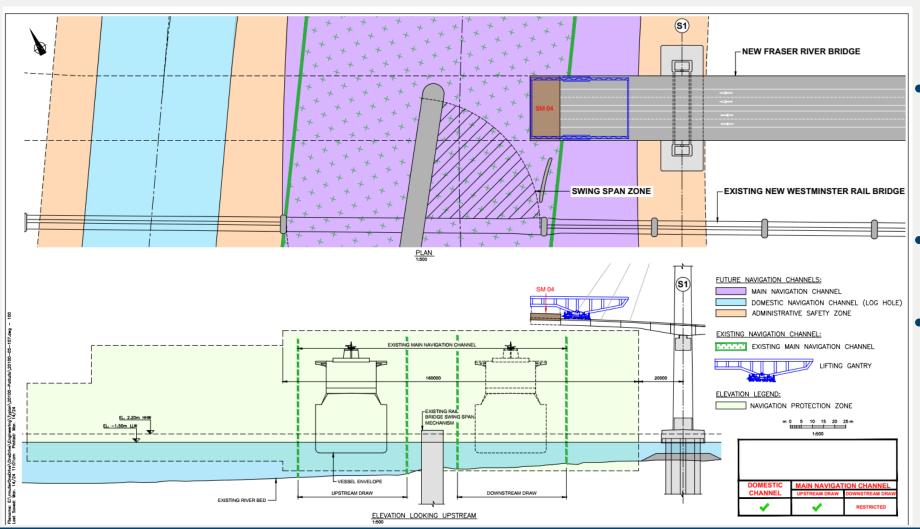
Construction Staging – Cantilever Construction Segment SM-04

- Late August pending operation of lifters
- Three-week duration
- Restrictions in the downstream draw (approx. 11 hours)
