# Marine Users Working Group

Presented By: Fraser Crossing Partners and  
Transportation Investment Corporation

February 27, 2025

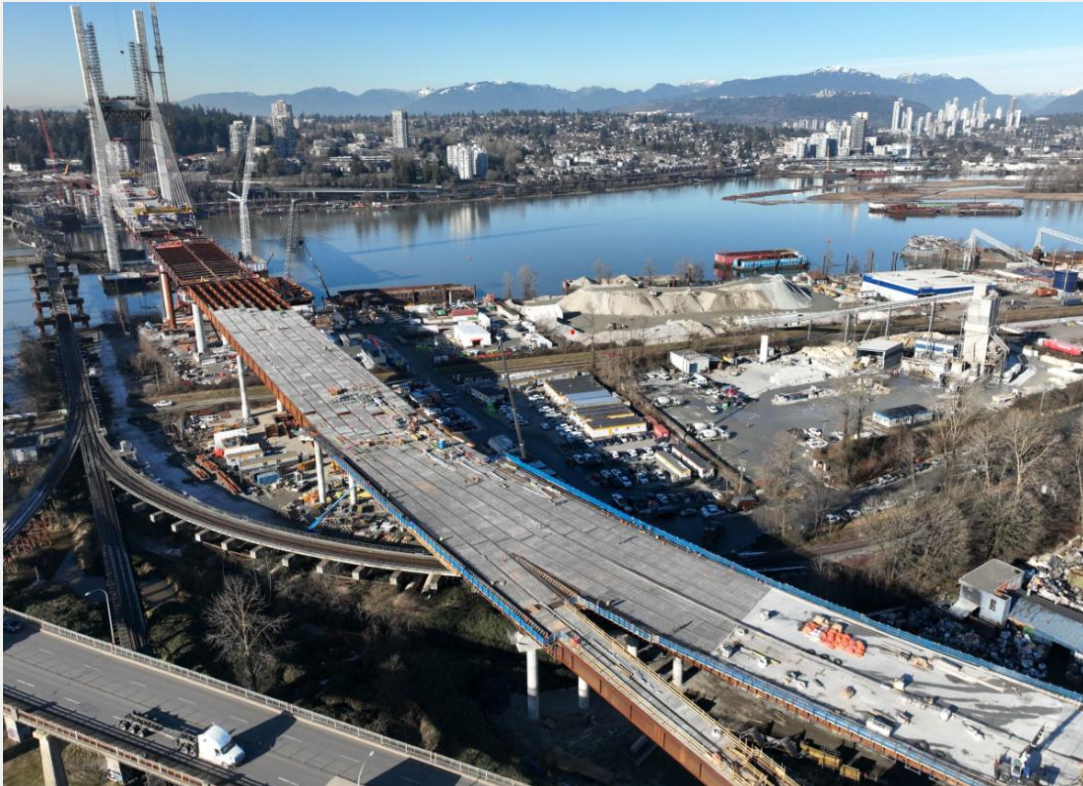
Photo 3: South Approach girder and deck installation

## South Approach Girder Installation

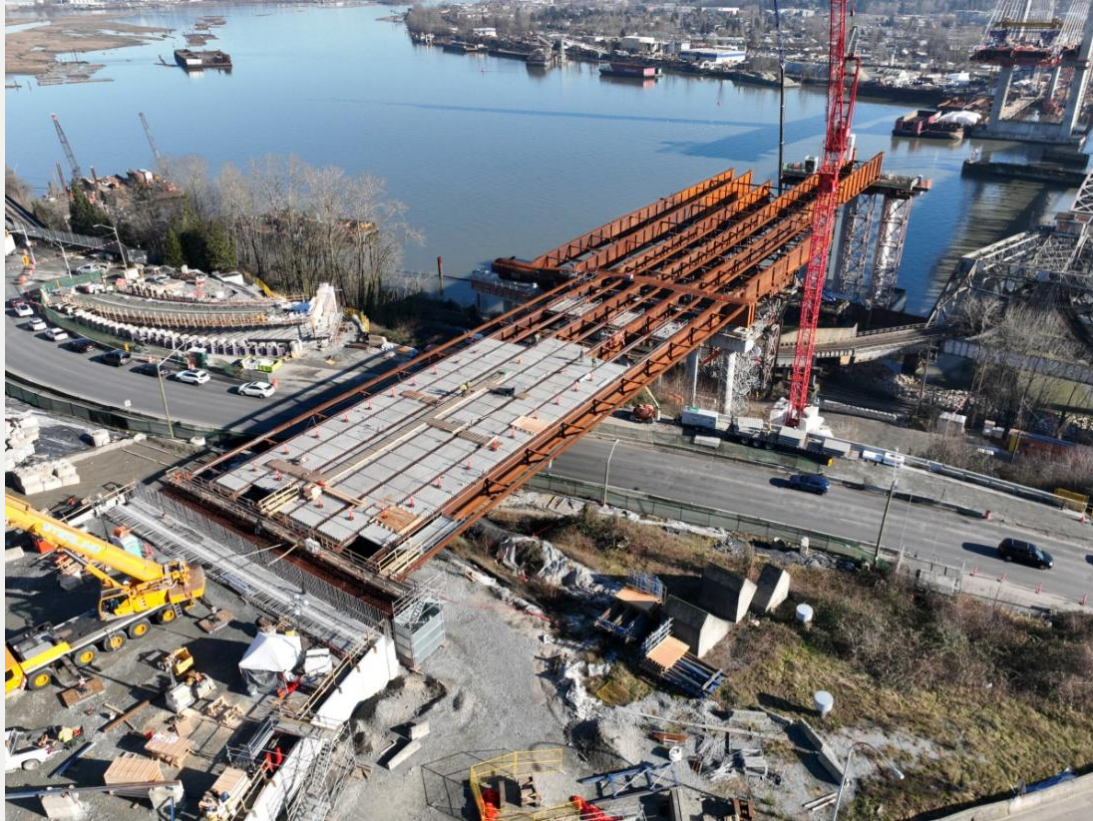
Photo 5: Ongoing girder installation at N1 Tower

## N1 Tower and North Approach Girder Installation

- FCP provided a Project update:
  - S1 Tower, cantilever construction, and girder installation ongoing (south girder installation close to main deck).
  - Steel installation ongoing at the N1 pier in New Westminster.

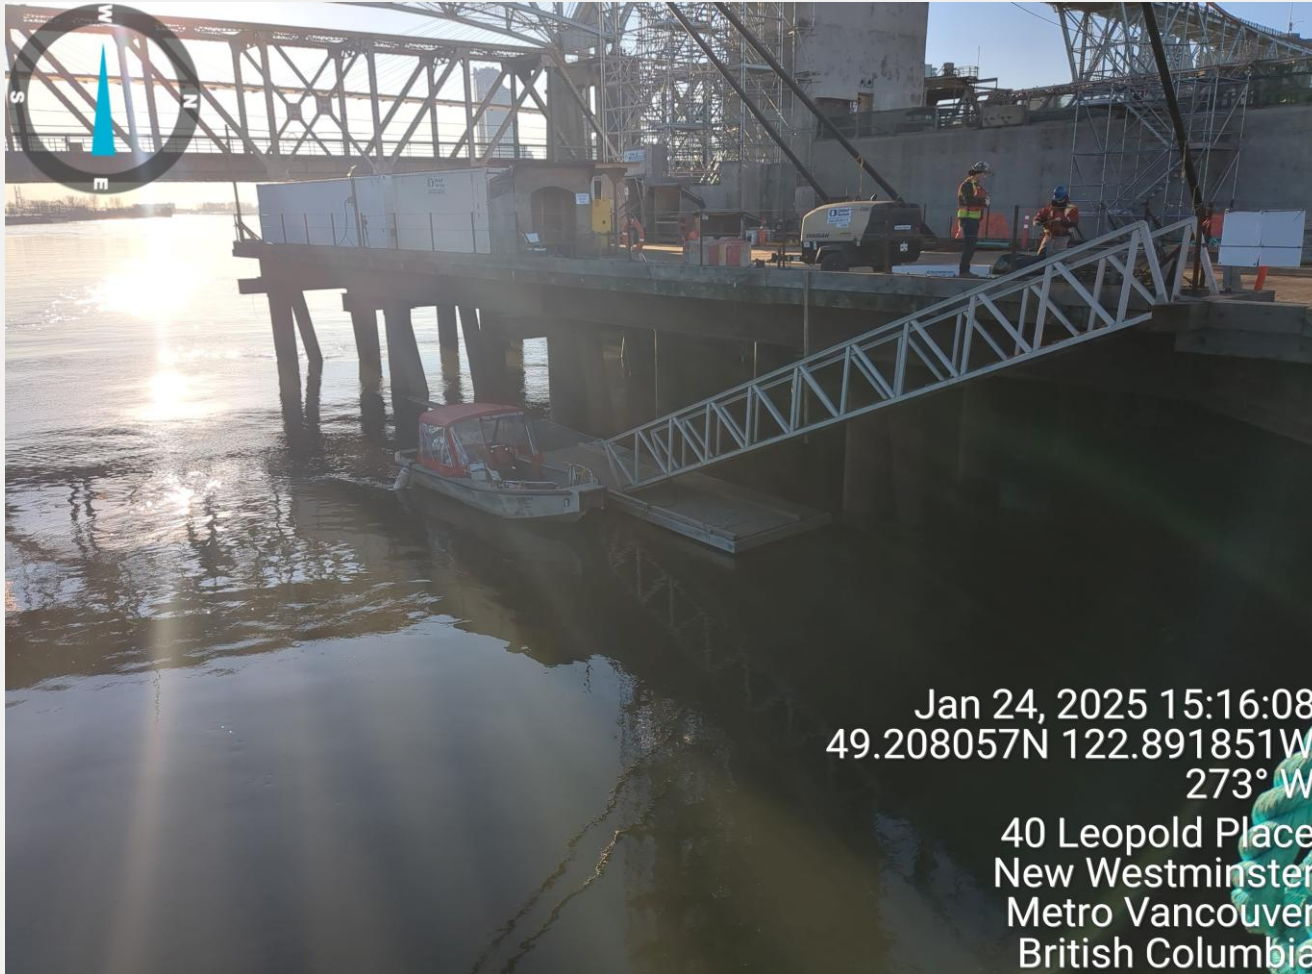
Photo: Current dock located on the trestle

- FCP provided a 4-week look-ahead:
  - Pier S2 soil densification work ongoing.
  - Marine access dock to be relocated, awaiting approvals.
  - SM-09 to SM-011 work ongoing with restrictions in the downstream draw.
