# Marine Users Working Group

Presented By: Fraser Crossing Partners and  
Transportation Investment Corporation

August 20, 2026

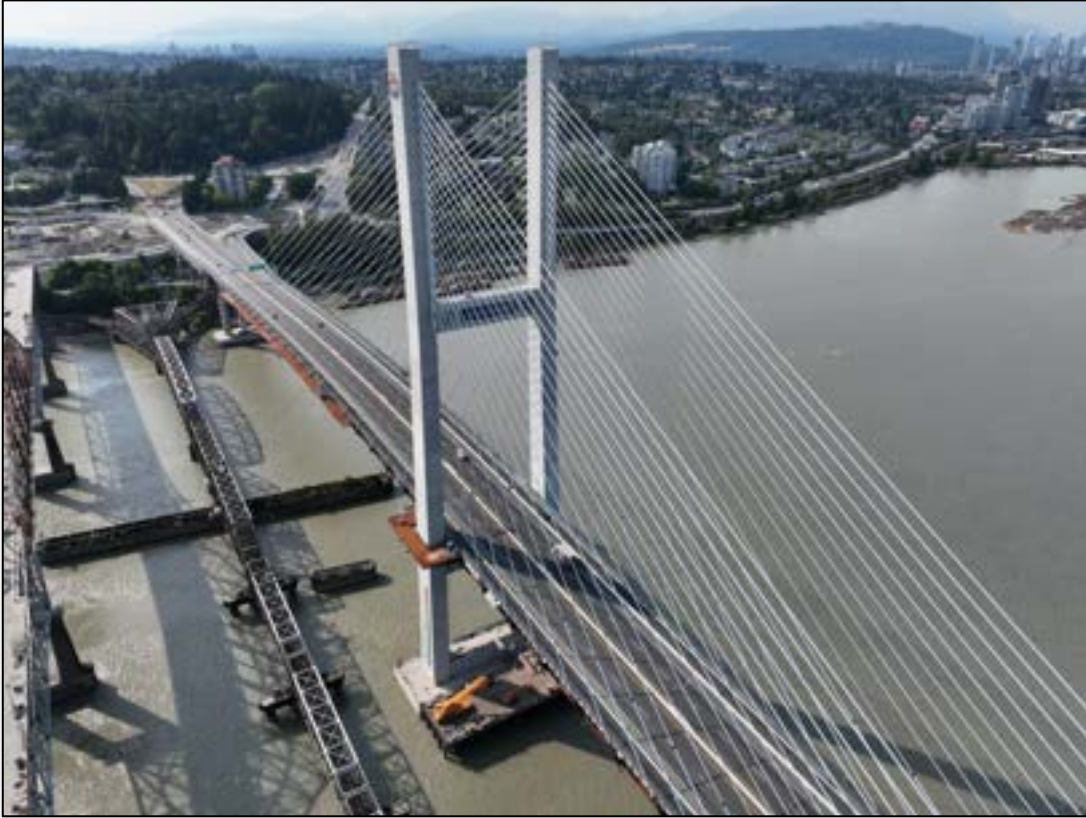
Photo 1: Bridge finishing works ongoing including installation of safety fence and artwork installations

- Navigation log
  - No updates to report during this cycle.
- FCP provided a Project update:
  - staləwasəm Bridge finishing work continues, including safety fence and artwork installation. S1 tower crane has been dismantled and removed.

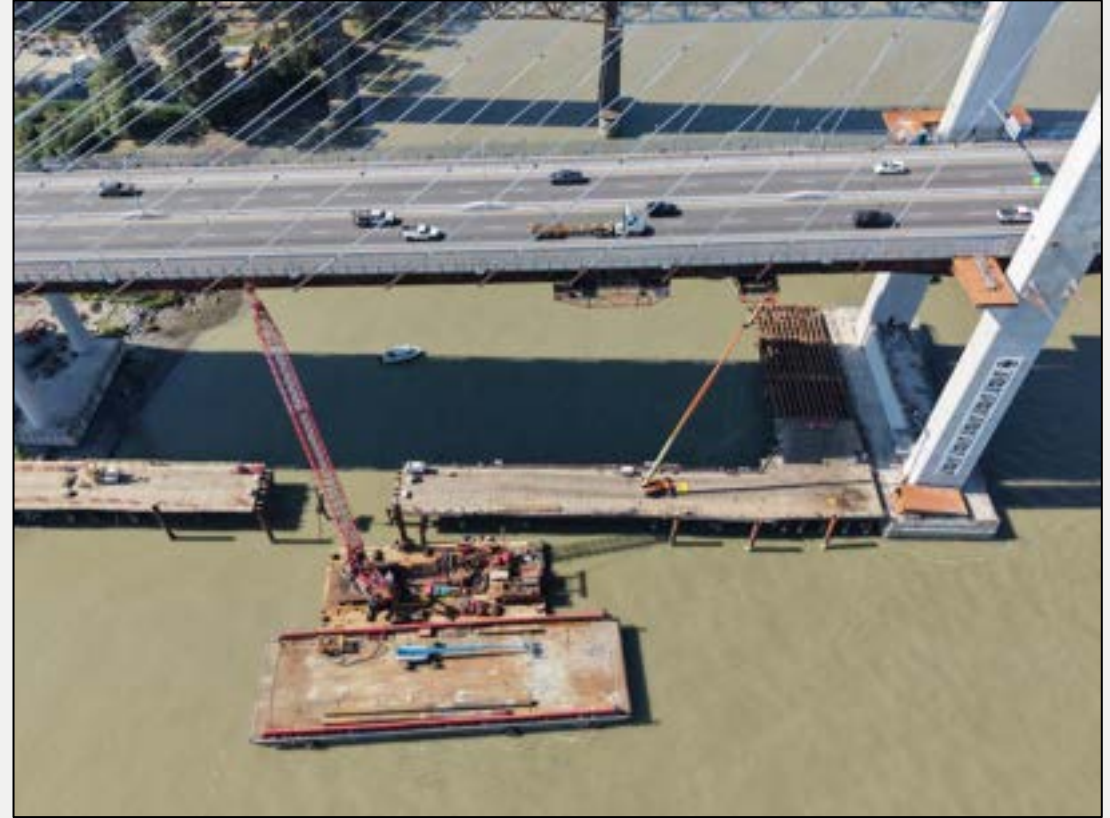
Photo 2: Pier S1 Temporary Work Platform (TWP) removal in process

- Removal of the Pier S1 temporary work platform began in late July involving removal of temporary trestles to accommodate soil densification work.
  - Following Span 3 deck removal, work is expected to shift to Span 5 in mid-August.

- Starting Aug 7; 3-4 week duration
- Involves removal of trestle superstructure and substructure
- Works will start in the middle of the trestle and work towards shoreline
- Implications to Navigation:
  - Works are located outside of the main navigation channel
  - Equipment placement will not create an obstruction to navigation

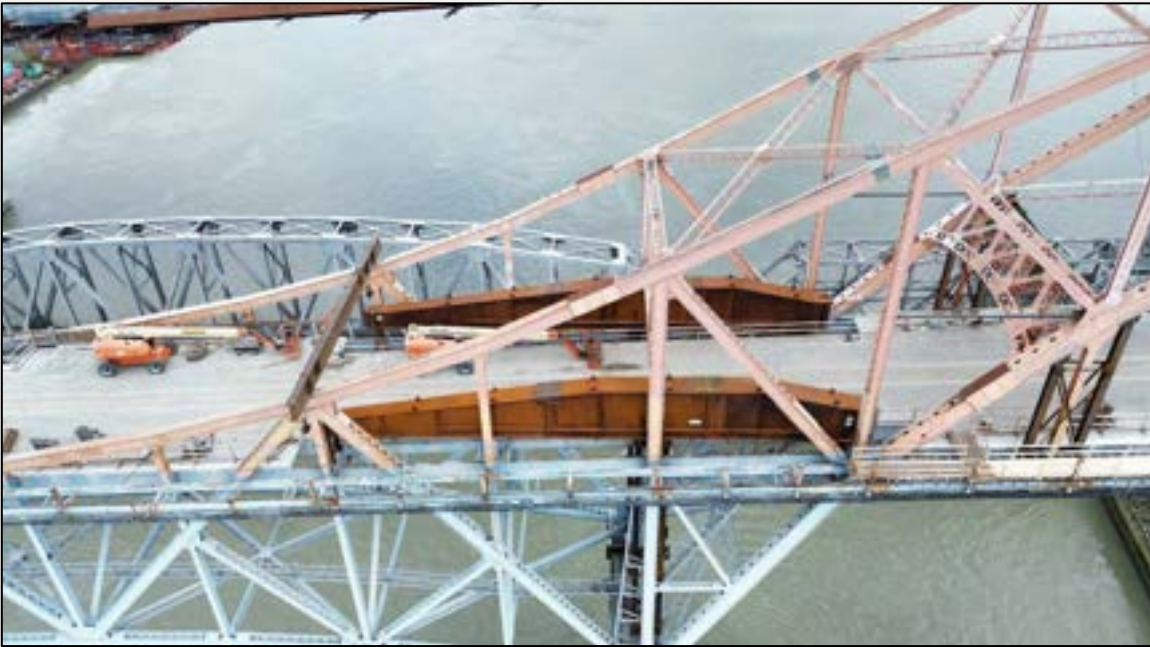
Photo 3: Installation of the Pier P3 jacking box beams and frame

- Demolition on the Pattullo Bridge deck includes installation of the Pier P3 jacking box beams and frames, as well as on-going concrete panel removal and preparation for lowering.

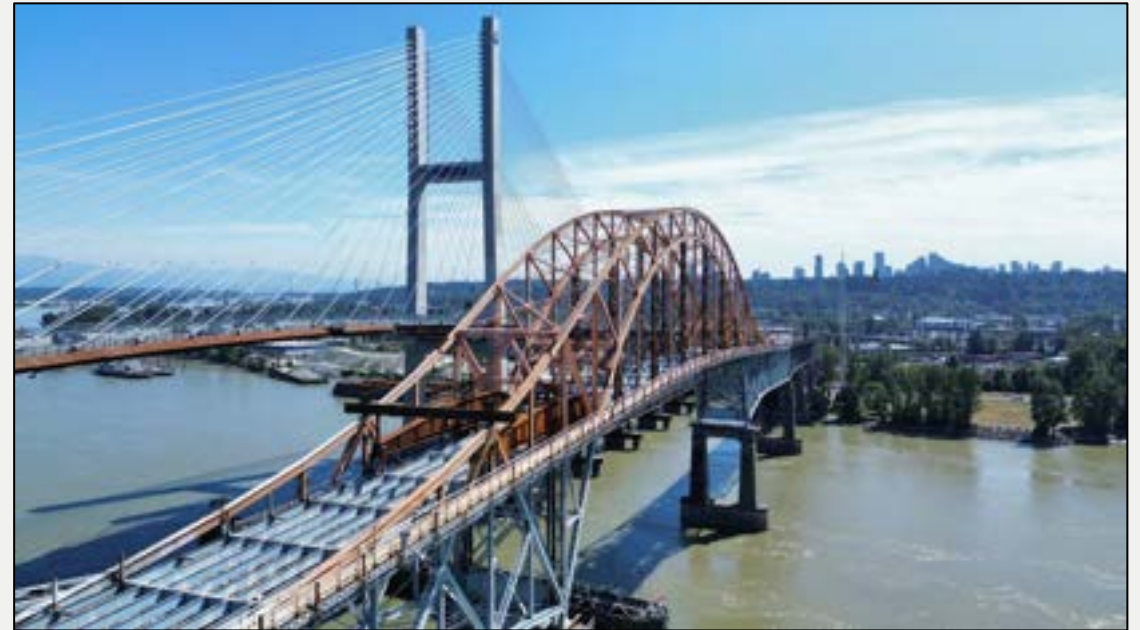
Photo 4: Vertical props and columns to support Span 4 (arch) lowering installed along Span 4

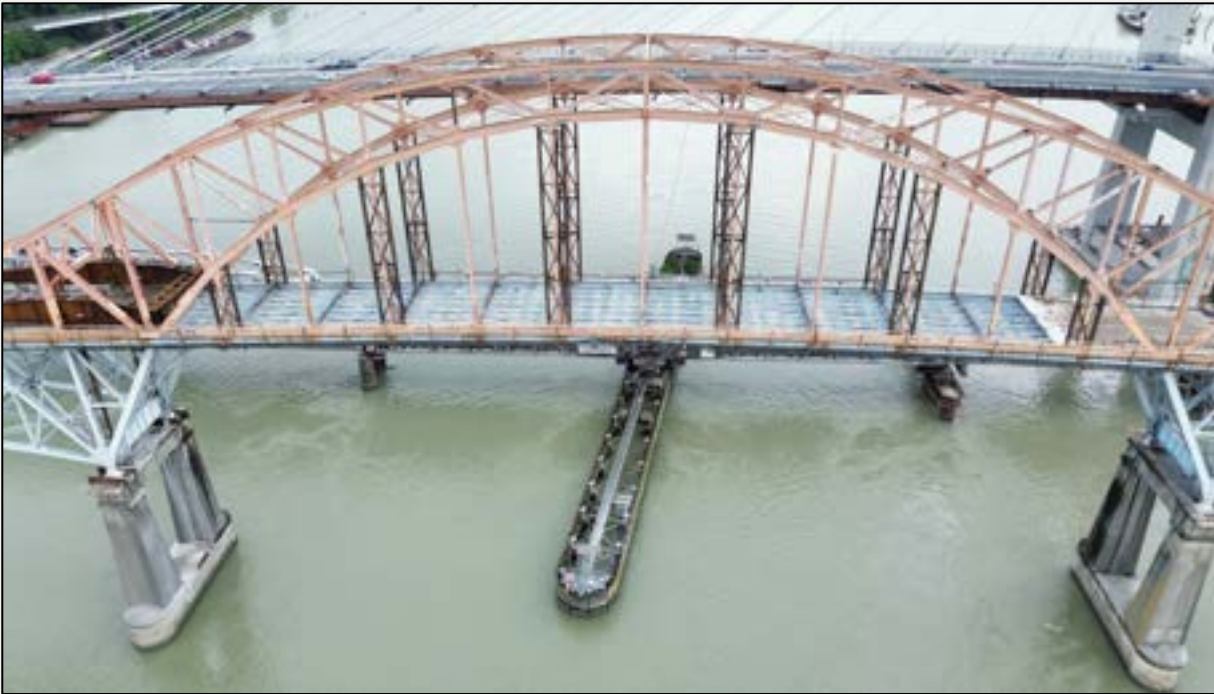
Photo 5: Span 4 bridge deck removal complete

- FCP provided a 4-Week Lookahead/Marine Staging:
  - Span 4 deck removal is complete; work is progressing to Span 3, with jacking beam and column installation underway at Pier P4.
